RENGSTORFF PARK MASTER PLAN

Capital Improvement Project 09-24

Adopted March 4, 2014

Rengstorff Park Inventory

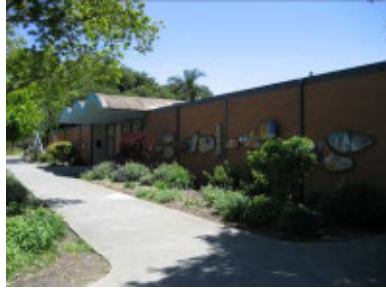
B1

The Aquatics Building is a one-story building approximately 4,730 square feet in size and 50 years old. It houses administration space, two locker rooms and equipment.

Based on the 'Property Condition Assessment' report completed in June 2007 by Shums Coda Associates, the Aquatics Building is "structurally and functionally in satisfactory condition" with the need for the following improvements:

- Roof replacement
- Exterior painting
- Structural upgrades
- Termite inspection and fumigation
- Renovation of administration area
- Minor accessibility upgrades
- Mechanical system upgrades
- Sewer system replacement

In 1991, the City had a hazardous materials investigation completed for this facility. The report noted a small amount of asbestos piping serving the water heaters in the facility. The piping does not present an exposure risk based on its conditions observed at the time of the report. The roofing for the facility was not testing as a part of the investigation; the report suggests further testing and investigation of the roofing materials at the time of any proposed renovation or demolition involving the roofing.

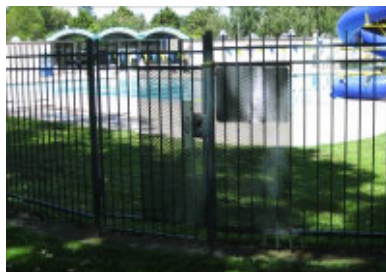
B3

The metal pool fence was also constructed in 1990 at the time of the pool renovation. The 6'-0" high fence serves to secure the pool from the rest of the park.

The fence and gates appear to be in good condition and functioning well. It is in need of cleaning and painting.

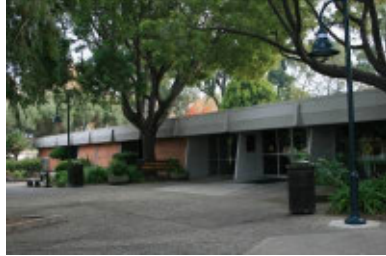
B4

The Community Center is a one-story building with a partial basement. It was built in 1963 to house the Community Services Department staff and provide space for community recreation programs and classes. Based on information provided in an Initial Study done in June 2002 the following work is needed at the building:

- Mechanical system replacement, including the addition of building wide air conditioning
- Electrical system replacement
- Plumbing and sewer systems upgrades
- Addition of fire sprinklers
- Significant accessibility upgrades

In 1991, the City had a hazardous materials investigation completed for this facility. The investigation noted a few hazardous materials present in the building: floor sheeting and packing around pipes. Neither of these materials presents an exposure risk based on their observed conditions at the time of the report. The roofing for the facility was not testing as a part of the investigation; the report suggests further testing and investigation of the roofing materials at the time of any proposed renovation or demolition involving the roofing.

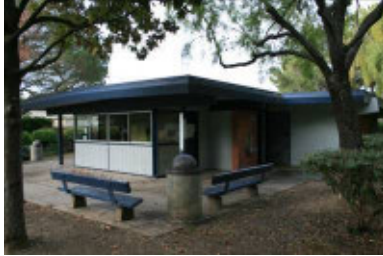
B5

The Ranger Building is a small one-story building approximately 1,476 square feet in size. Originally built in 1963, the building was expanded to its current size in 1964. It houses office space, public restrooms, staff locker rooms with showers, break room, and electrical equipment.

Based on the 'Property Condition Assessment' report completed in June 2007 by Shums Coda Associates, the Ranger Building is "structurally and functionally in satisfactory condition" with the need for the following improvements:

Given the age of the structure and common building practices at the time of its construction, it is possible that the building contains hazardous materials. Further testing and investigation would be needed to determine the presence of any materials of concern.

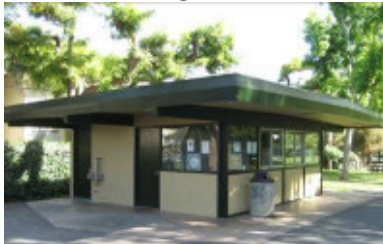
B6

The Tennis Building is a small one-story building constructed in 1964 in conjunction with the tennis courts, grandstand, and handball courts. It is approximately 400 square feet in size. The building's primary use is during tennis tournaments as an administrative base and snack bar.

The building appears to be in good condition. Due to its age and time of construction, it is believed that improvements needed at this building are similar to those at the Ranger Building:

Given the age of the structure and common building practices at the time of its construction, it is possible that the building contains hazardous materials. Further testing and investigation would be needed to determine the presence of any materials of concern.

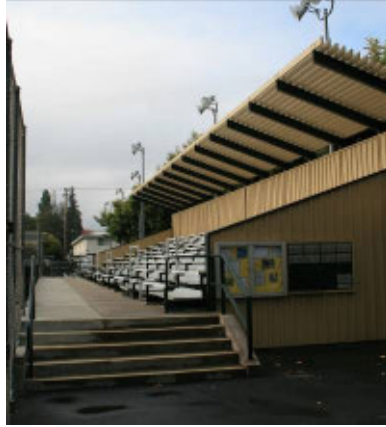
B7

The tennis grandstand was constructed in 1964 and renovated in 2009. The recent renovations have made the stands more widely accessible. The stands also provide a storage area under the seating that appears to not be used.

The structure appears to be well maintained.

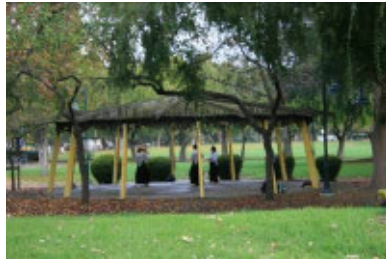
B8

The pavilion was constructed in 1964. The construction drawings indicate that the pavilion was intended to support the City's day camp programs, and it still fulfills this role today.

The wood framing that forms the roof of the structure appears to need replacement, due to deterioration from weather. The steel frame portion also shows considerable wear from the elements and needs to be cleaned and painted.

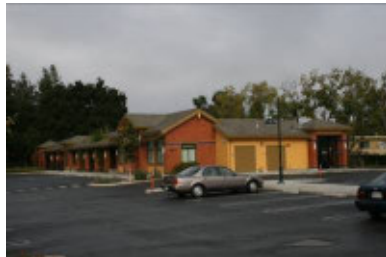
B9

Built in 2007, the Childcare Center is the most recent structure to be built at the park. It is a one-story building of approximately 8,623 square feet. The structure contains several modular buildings with a wood framed building surrounding and connecting the modular parts into a single facility. This facility is owned by the City and operated by the Children's Creative Learning Center, a division of Knowledge Learning Corporation (a private company based in Delaware). The childcare services available range from infant care to pre-kindergarten daycare.

The building appears to be in good condition and well maintained.

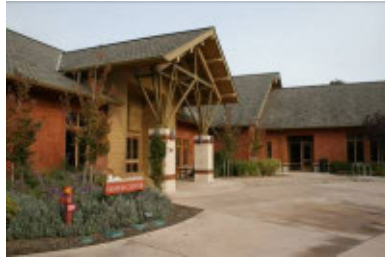
B10 Senior Center

The Senior Center is a two-story building of approximately 23,600 square feet in size. It was constructed in 2005 as an all-purpose facility for adults over 55 and provides space for a variety of programs and services.

The building appears to be in good condition and well maintained.

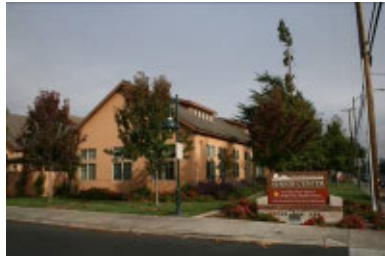
B11 Avenidas Senior Day Health Center

The Avenidas Senior Day Health Center was built in 2005. A two-story building of approximately 9,500 square feet, the Center provides day health care to adults with a variety of medical conditions. The building is owned by the City and operated by Avenidas, a community-based nonprofit organization based in Palo Alto.

The building appears to be in good condition and well maintained.

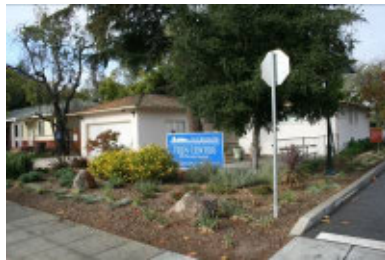
B12 Teen Center

The Teen Center, also referred to as “The House,” has been in operation at its current location for approximately 10 years. Renovated significantly around 2007, the one-story building of about 1,990 square feet provides a wide variety of after school programs for middle school teenagers.

The building appears to be in good condition and well maintained.

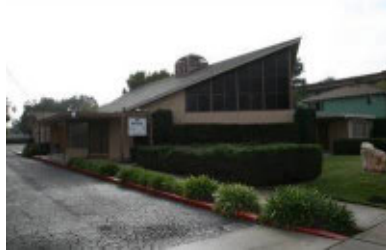
B13 Rock Church

The Rock Church building is a recently acquired City property adjacent to the park, across Escuela Avenue from the Avenidas Senior Day Health Center. The property is to be included in the Master Planning effort for Rengstorff Park. The building is a one-story building, approximately 8,500 square feet in size. The chapel, built around 1961, was an addition to the existing social hall that was constructed at an unknown earlier date.

In November 2008, the City hired a structural engineer to perform a limited evaluation of the building. The findings identified that the building is in good condition overall and noted a need for further evaluation of shear walls in both the social hall and sanctuary spaces. Based on a brief tour of the facility, Anderson Brulé Architects, Inc. was able to make the following observations:

- Accessibility upgrades to the facility may require a significant amount of renovation to provide accessible paths of travel throughout the building
- The restrooms serving the facility would require upgrades for accessibility as well as potentially increasing the quantities of fixtures provided. The fixture counts are low for the facility's current use. Fixture counts for the facility's potential new uses would need to be evaluated.
- The roof is in need of repair.
- No documentation was available on the mechanical and electrical systems. Anecdotal information provided by church staff indicates that both systems are functioning well.
- The future use of the building is unknown at this time. If there is a change in use of the building, the building codes would require significant upgrades to the structure to bring it into compliance with current regulations.

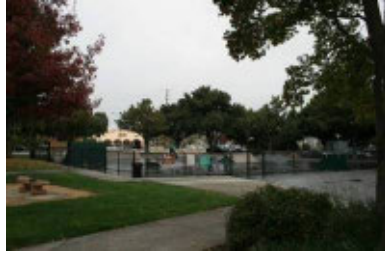
R1

Built in 1997 as a demonstration and temporary facility, the skate park was expanded and became a permanent feature of the park in 2000. It is located in the northwest corner of the park and makes use of approximately 10,000 square feet of park area. Highly utilized, the facility appears to be in good condition with on-going maintenance needed for graffiti.

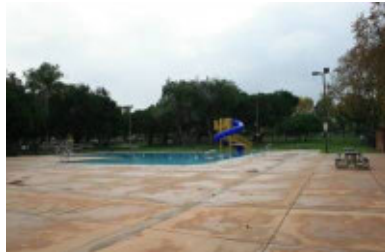
R2

Rengstorff Park has two pools that were built in 1959 and renovated in 1991 and 2006. Both pools are open in the summer months and include a 4,830 square foot lap pool with diving boards and slide and the smaller wading pool.

The pools are highly used and appear to be well maintained.

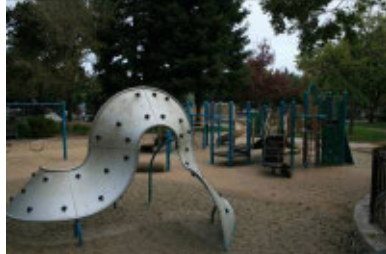
R3 Tot Lot/ Playground (at Rengstorff)

The playground located in the northwest corner of the park near Rengstorff Avenue appears to be highly used and well loved by the community. Originally built in 1991 and renovated in 2007, this area provides a wide variety of play equipment for children.

Several of the rails and play equipment pieces are showing signs of wear that may be from uses other than those intended for the equipment (i.e., skateboarding, BMX bikes, etc).

- Dropoffs between paving and play areas do not have detectable warnings.
- Play structures do not have transfer platforms located on an accessible path of travel.
- Accessible paths of travel are required to all play areas and should be firm, resilient safety surfaces.

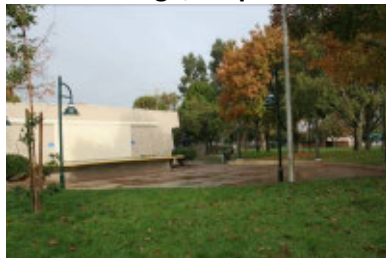
R4 Outdoor Stage/Amphitheater

The outdoor stage and amphitheater, located at the rear of the Community Center, is over 45 years old. In addition to showing signs of wear, the stage structure does not have a means of disabled access unless accessed from inside the Community Center. The stage also presents a potential hazard to the visually impaired due to the cantilevered design.

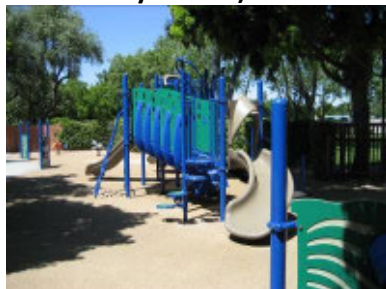
R5 Tot Lot/ Playground (at Community Center)

The Community Center has a playground area directly adjacent to a space where daycare services are provided. This space is available for use by the public only after daycare hours.

Originally built in 1984 and renovated in 2008, this area has been well maintained and appears to be in good condition.

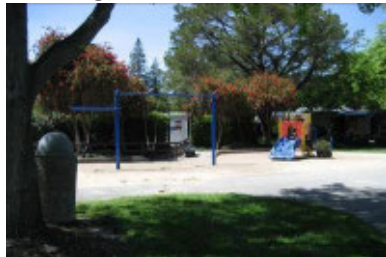
R7 Tot Lot/ Playground (at Ranger Building)

The playground located near the Ranger Building is one of the smallest in the park. This area was renovated in 2008 and is well maintained.

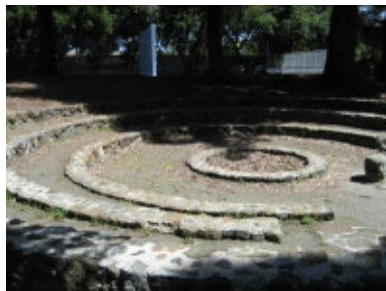
R8 Fire Circle

The fire circle was part of the improvements that were completed in 1964. This area was designed to support the City's summer day camp programs and still serves this function. The area has a few weeds, but otherwise is well maintained and functional.

In 2002 and 2005, the City had an accessibility assessment done of its facilities. The following items are of note for the Fire Circle:

- Accessible seating has not been provided within the Fire Circle.
- The central dais area of the Fire Circle is not accessible.

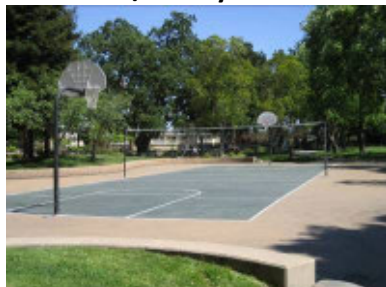
R9 Basketball/ Volleyball Courts

Near the picnic areas off Crisanto Avenue, the park contains two courts that can be used for basketball or volleyball. These courts were installed in 1992 along with the improvements to the picnic area. Other than needing cleaning, the courts are well maintained and functional.

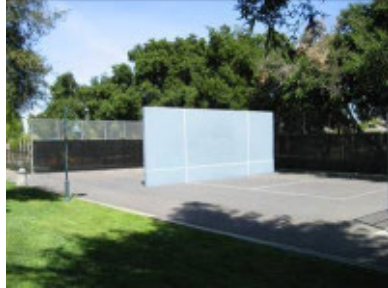
R10 Handball Courts

Originally constructed in 1964, the handball courts have been well maintained and updated over the years. The fence surrounding the courts was added in conjunction with the development of the Childcare Center in 2007.

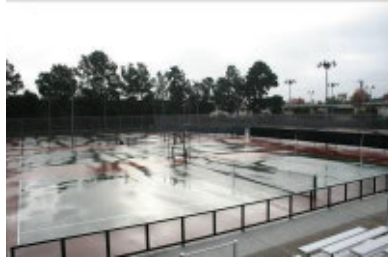
R11 Tennis Courts

The tennis courts have been a part of the Park since 1964 and are a highly utilized facility that hosts tournaments in addition to being available to the public for open play. The tennis courts were re-surfaced in 1993, 1998, and 2005 with plans for another re-surfacing in fiscal year 2010-2011. The City has a very robust maintenance program for tennis courts and they are kept in excellent condition.

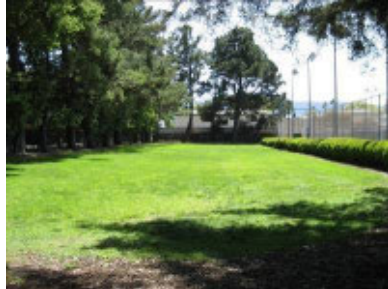
R12 Off-Leash Dog Training Area

The off-leash dog training area is one of the more underutilized areas of the park. Originally designed for horseshoes and archery, this space is now dedicated solely for specialized instruction including service guide dog and search and rescue training. Use of the area for off-leash training requires a permit. This area is well maintained.

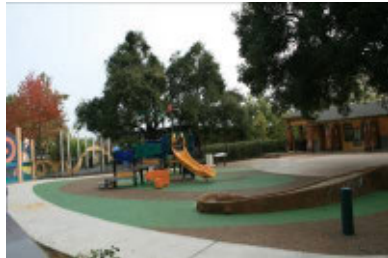
R13 Childcare Center Playground

Built in 2007, this playground is used primarily by the Childcare Center but is open to the public after 6:30 pm during the week and all day on weekends. Approximately 8,140 square feet in size, this playground provides a wide variety of play opportunities. The fence separating the playground from the surrounding park area is a piece of public art.

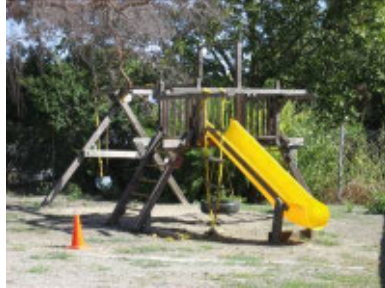
R14 Rock Church Play Structure

Near the rear of the Rock Church parking lot a play area of roughly 450 square feet has been established. This area features a single wooden play structure. Although the age of the equipment is unknown, it shows signs of considerable wear. It is unknown if this structure will remain on the site once the church vacates the property.

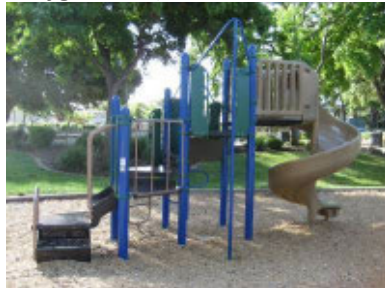
R15 Playground (at Picnic Area)

Tucked between the Family Picnic Area and the Group Picnic Area is the smallest play area in the park. Renovated in the early 1990s, this area has been well maintained and appears to be in good condition.

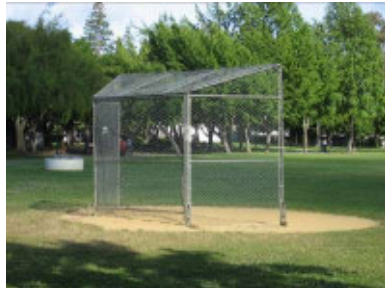
R16 Backstop

Rengstorff Park contains two baseball backstops in the open lawn area furthest from Rengstorff Avenue. Although formal organized use of the field space is not permitted at the park, these backstops are used for many informal pick-up games. The age of the backstops is not known and, while they show some signs of aging, they are well maintained and continue to function as intended.

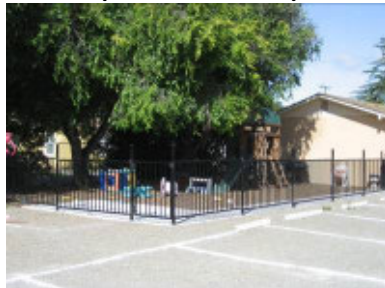
R17 Tot Lot (at Rock Church)

The Rock Church property includes a fenced-in Tot Lot of roughly 1,525 square feet directly adjacent to the classroom area. While most of the play equipment in the area is portable and will likely be removed when the church vacates the property, one moderately sized wooden play structure may remain. The structure appears to be relatively new and in good condition.

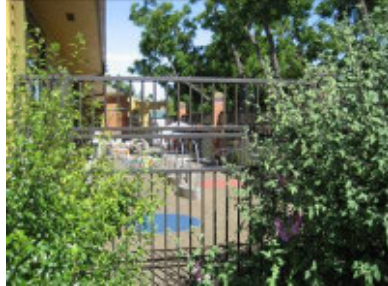
R18 Childcare Center Tot Lot

Built in 2007, this Tot Lot is used primarily by the Childcare Center. Approximately 1,270 square feet in size, this area provides a wide variety of play opportunities. There are a number of built-in play features along with many portable large-scale toys in this space. It appears to be well maintained and in good condition.

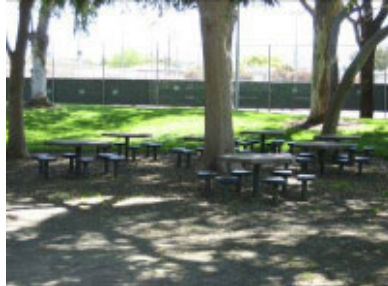
R19 Picnic Tables (at Pavilion)

Adjacent to the Pavilion is a picnic table area with 8 tables with 6 seats at each table. This area was constructed in 1964 with the intention of supporting the City's summer day camp programs, a role the area still fulfills.

The tables are showing signs of their age, but are still functional and have been maintained over the years. This area is highly utilized by the City for its summer programs.

In 2002 and 2005, the City had an accessibility assessment done of its facilities. This assessment noted that the Picnic Tables at the Pavilion do not provided for accessible seating.

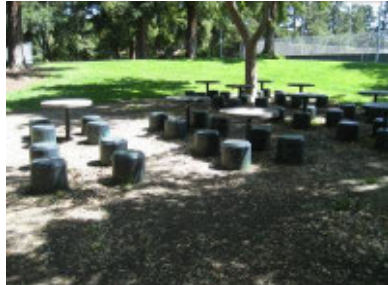
R20 Picnic Tables (at Fire Circle)

Adjacent to the Fire Circle is a picnic table area that has 12 tables with 4 seats at each table. This area was also constructed in 1964 to provide space for the City's summer day camp programs.

The tables are showing signs of their age, but are still functional and have been maintained over the years. This area is highly utilized by the City for its summer programs.

In 2002 and 2005, the City had an accessibility assessment done of its facilities. This assessment noted that the Picnic Tables at the Fire Circle do not provided for accessible seating.

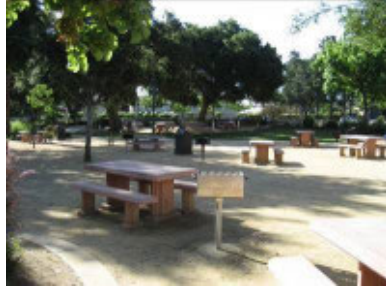
R21

The Family Picnic Area has 18 picnic tables and individual barbeques. From May to October, the picnic areas are available for reservation through the City's Recreation Department.

Originally built in 1963 and renovated in 1992, this is highly used area of the park that is well maintained.

In 2002 and 2005, the City had an accessibility assessment done of its facilities. This assessment noted that the Family Picnic Area do not provided for accessible seating and the barbeques are also not designed for use by the disabled.

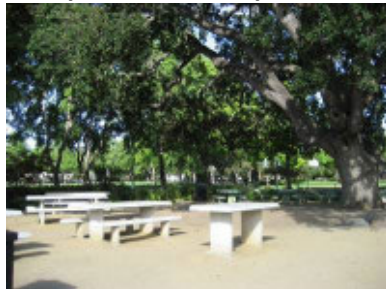
R22

The Group Picnic and Barbeque Area has five group areas that can host 50 people each for the total of 250 picnickers. From May to October, the group areas are available for reservation through the City's Recreation Department. It is also the only location in the park where alcohol is permitted.

Originally built in 1963 and renovated in 1992, this is highly used area of the park that is well maintained.

In 2002 and 2005, the City had an accessibility assessment done of its facilities. This assessment noted that the Group Picnic Area do not provided for accessible seating. This area also features a sink and barbeques that are not designed for use by the disabled.

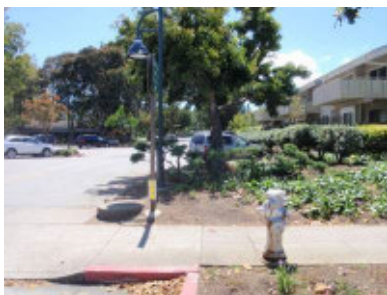
L1

Large Carob Trees flank the entry drive at the Community Center with ivy, Juniper, and turf as ground cover. This low-maintenance area is in need of clean up and additional mulch.

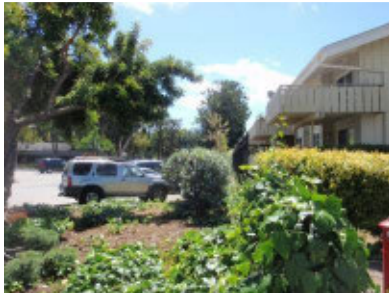
L2

Tristania trees have been recently planted along the property line to replace the old pine trees that have been removed. These trees will serve the park nicely as they mature.

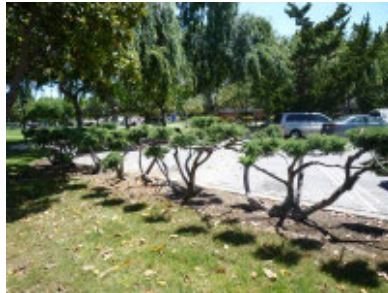
Juniper hedge has been pruned into bonsai shrubs, which is an ineffective use as a hedge screen for the parking area along Rengstorff Avenue. If screening of the parking is desired at this location the juniper shrub should be replaced with a more suitable hedge shrub.

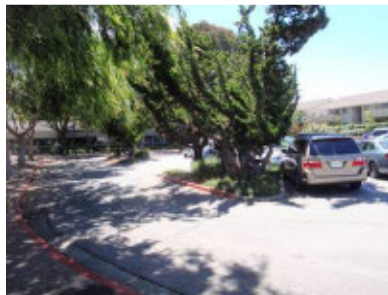
Hollywood juniper trees in the parking lot end islands are not suitable parking lot trees. The dense branching blocks the parking lot lights creating unsafe conditions. These trees could be replaced with proper canopy trees to improve the conditions.

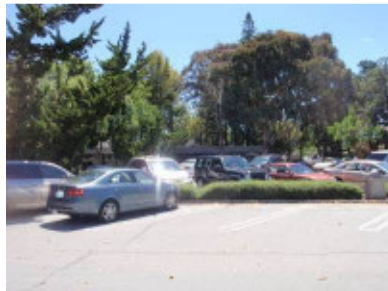
L7

Shrub planting within parking lot has some thin spots, but overall growth looks good. The addition of canopy trees to the area would provide shade for parked cars.

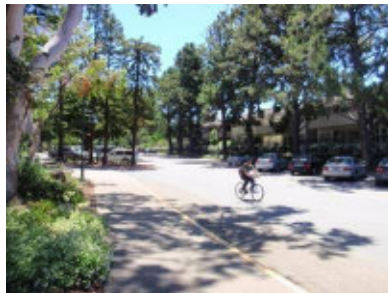
L8

Redwood trees are in small, confined areas in parking lot. The trees need more space to grow and appear to be struggling to survive in their current locations.

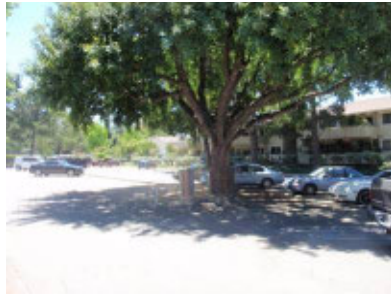
A large Carob tree in the small parking lot island has its growth restricted and is struggling to survive. Expanding the island around the tree could improve its conditions and help increase the tree's longevity. No shrubs or ground cover plantings have been installed in this parking area, making it less aesthetically pleasing than adjacent areas.

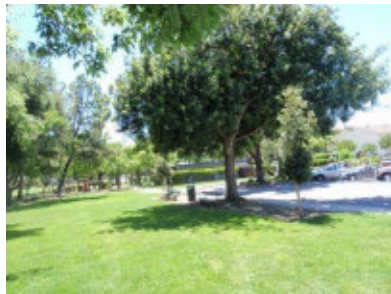
L10

Mature Oak trees adjacent to sidewalk along parking lot are in good health. Two newly planted Oak trees appear to be in good health as well.

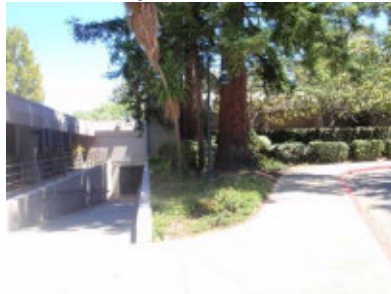
Redwood trees in this area are large and mature. Located in a small planting area, the trees are healthy and thriving. Tree roots have lifted the adjacent sidewalk paving, but the patching has been done to make the sidewalk usable. The sidewalk should be monitored for future repair needs.

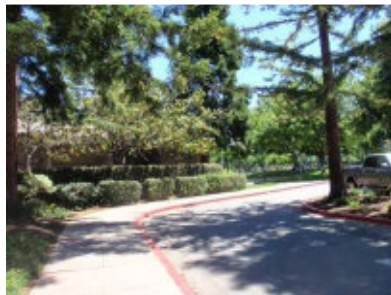
L12

Magnolia trees adjacent to the Community Center building have thick canopies that are showing signs of decline. These trees should be removed. Shrub hedge has become overgrown for the scale of the building. Given the age and state of overgrowth, removing the hedge and replanting with new plant material should be considered.

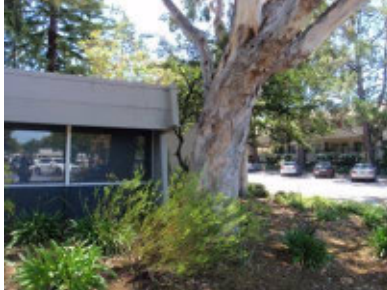
L13 Community Center - West

A large mature Eucalyptus tree is too close to building corner. The tree seems to be in good health however, it has outgrown the space available at this location.

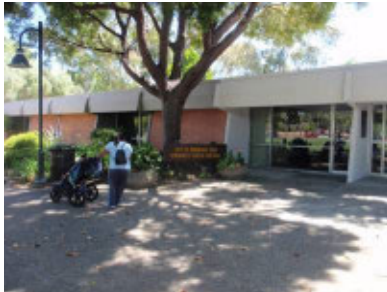
L14 Community Center - Northwest

Near the entry to the Community Center, a large mature Podocarpus tree is in good health. The tree is a little close to the building however, the proximity does not appear to negatively impact the tree. Shrubs have been over maintained by shearing. Planting beds are planted sparsely and at random. To improve the visual character of the landscaping, developing a consistent shrub and ground cover theme should be considered. The planting beds are also in need of mulch cover..

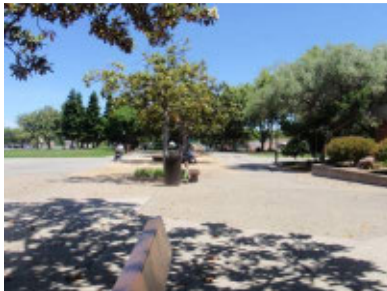
L16

Olive trees at the building corner are healthy and providing a nice visual and landscape accent.

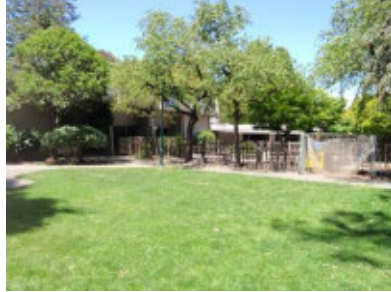
An evergreen pear tree and white alder tree adjacent to the play area are not in good health. The shape of the trees is inconsistent and not symmetrical. For visual consistency, replacing these trees with a more fitting native species should be considered. The Japanese Maple appears to be in good condition.

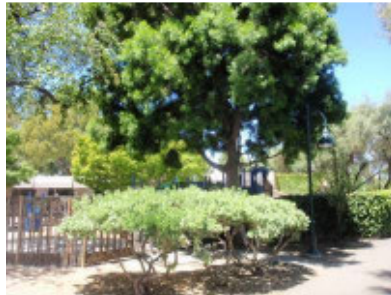
L18

Pittosporum shrubs around play area have been pruned heavily eliminating all foliage at the base of the plants. All the plants should be removed from the planting areas around play area.

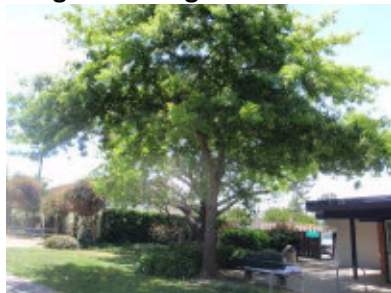
L19

Mayten trees are in good health, although planted close to the building. If the tree location presents no negative effect to the building, it should remain as is. Shrub planting has become overgrown, consider thinning out or replacing with a new planting design theme.

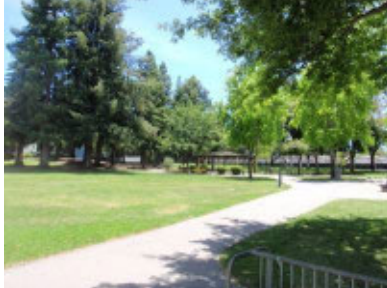
L20

The pine tree grove near the Pavilion and Ranger Building is very healthy and should be retained. The Oak tree and Saucer Magnolia tree around building in good health and should be maintained.

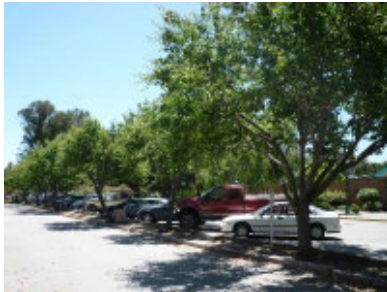
The pear trees in the parking lot have outgrown the narrow planting space, although they are in fair health. Root guard/barriers for the trees are exposed and unsightly. The median is bare dirt. The trees should be replaced with a species appropriately sized for the space available.

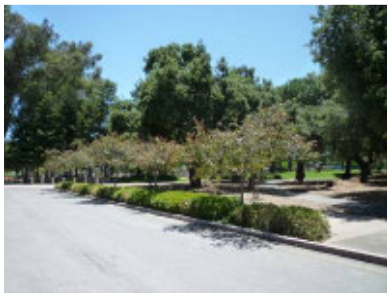
L22

Ornamental plum trees with Indian Hawthorn shrub planting are healthy. These elements create a nice pedestrian scale buffer between the parking lot and sidewalk.

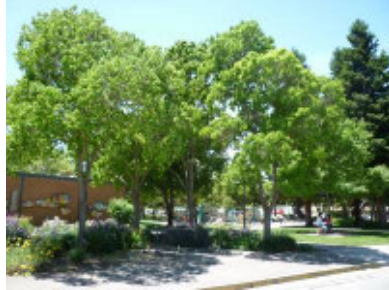
L23

Silk oak trees are healthy, although surface roots are showing. Consider adding a small layer of topsoil to cover roots. Shrub and ground cover planting is scattered and inconsistent. Irrigation tubing is exposed and planting beds are in need of mulch.

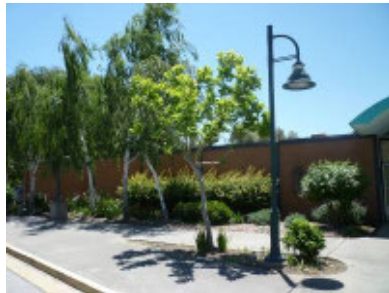
L24

Building foundation planting is random and scattered. To improve the visual character of the landscaping, developing a consistent shrub and ground cover theme should be considered.

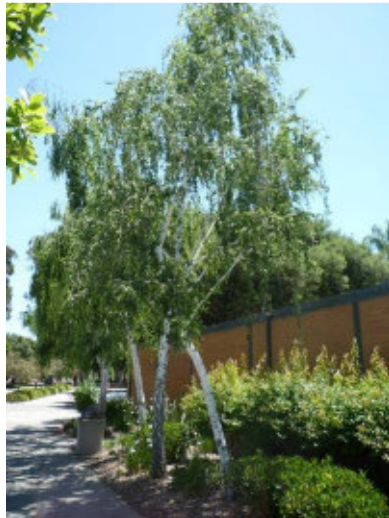
L25

Birch trees in planter wells are in fair condition. Foundation planting is random and scattered. To improve the visual character of the landscaping, developing a consistent shrub and ground cover theme should be considered.

Large mature Oak trees at the edge of the parking area provide a nice a entry statement. Large expanse of mulch area at the base of the tree is adequate. Consider adding shrub and ground cover planting strategically for aesthetics.

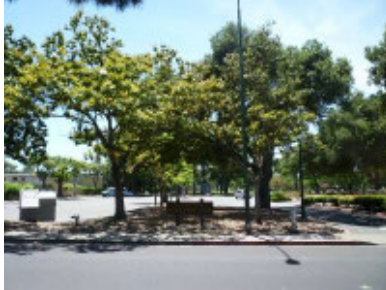
L26

Magnolias with large Oak at entry from Crisanto Avenue are healthy, but are not a good pair. The large Oak tree should be retained and a more complimentary tree species should be found to replace the Magnolia trees. Shrub and ground cover planting could also be added to this entry.

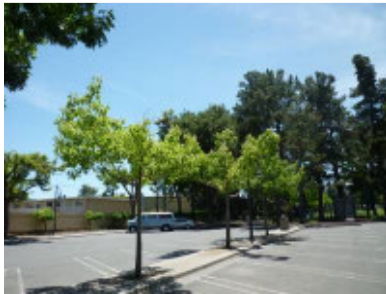
Red Oak trees are in poor health and should be removed. Small ornamental trees at entry area are visually pleasing and in good condition.

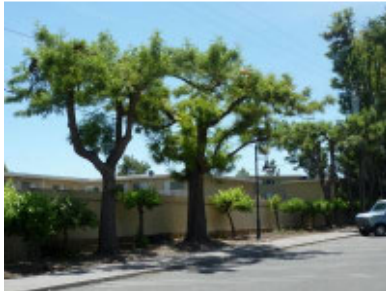
L28

The Dwarf Pear trees have been trimmed to remain below the site wall. The large trees have been topped for power lines. This perimeter planting does not serve as screening of the parking lot or adjacent properties. The area should be re-planted with appropriate screening planting material.

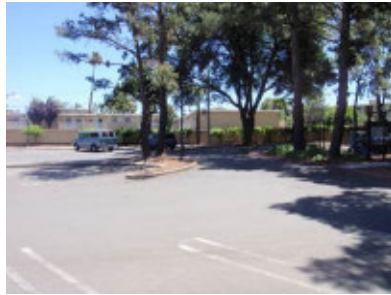
The pine tree grove at major utility station is in declining health and the trees are not symmetrical. Shrub and ground cover planted are not adequate for screening the utilities. This planting should be replaced with appropriate screening material.

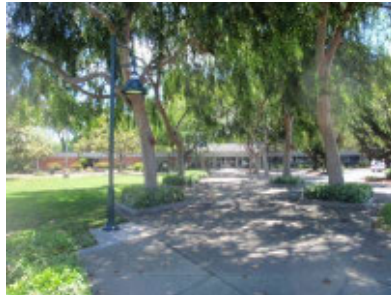
L30

Chinese elm allee approach to building provides a strong entry statement. There is one tree missing from the group and should be replaced to reinforce this entry statement.

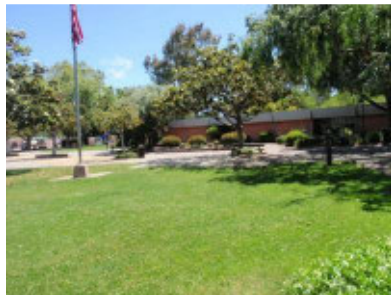
The magnolia trees are generally in good condition, with the exception of one tree of the group and should be replaced. The lawn has a considerable amount of dandelion growth and a herbicide should be considered to address the issue. The plaza paving has wood expansion joints that are not sustainable and will rot over time.

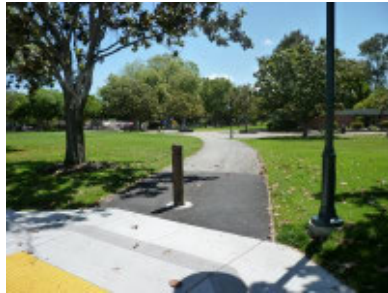
L32

The asphalt park path connecting to Rengstorff Avenue appears to be newly constructed or repaired park with bollards at the crosswalk entry. This area also features a new disabled ramp and crosswalk across Rengstorff Avenue.

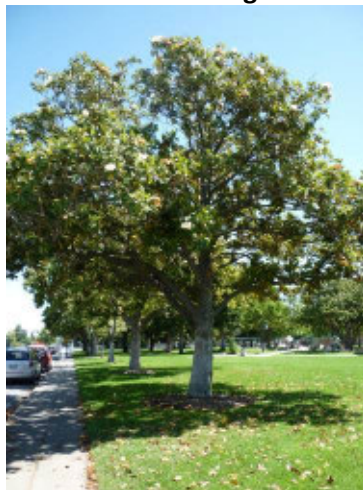
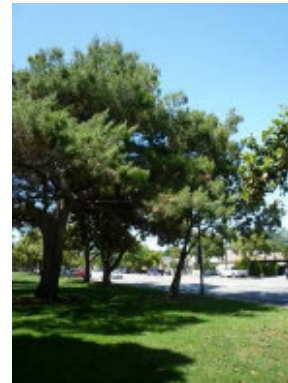
L33

Magnolia trees planted along Rengstorff Ave. are healthy overall. There is one small Magnolia being crowded by a large pine and should be removed to allow the pine tree to continue to be healthy. Newly planted Redwood tree in mulch area is healthy and will grow to be a nice accent on corner. The large areas of mulch could benefit from ground cover planting.

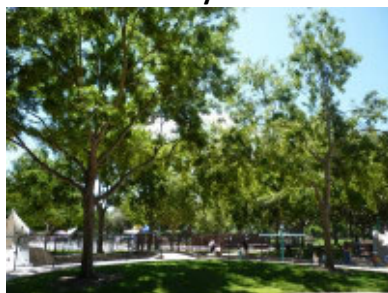
L34

Elm trees seem to be in good health even though the surface roots are exposed. Mulch rings at the base of trees to cover the exposed roots should be considered.

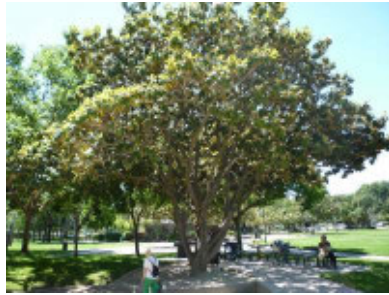
L35

The Children's Play Area near Rengstorff Avenue features Magnolia trees with low branching used for climbing. The soil around base of all the trees is hard-packed which means the trees are probably not getting adequate water, although they appear to be in good health.

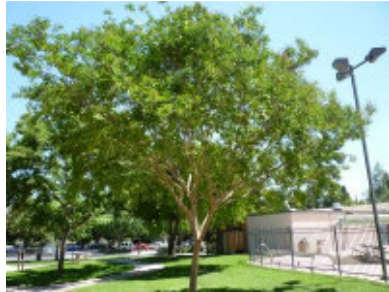
L36

Crape myrtle trees adjacent to pool fence are spectacular and appear to be thriving in the current location. Consider adding mulch to at the base for dressing.

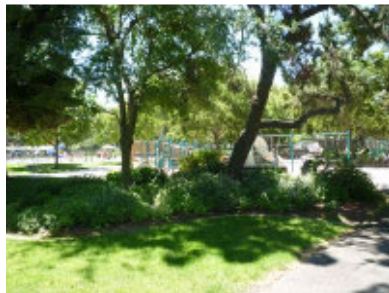
L37

Lawn area is lush and green. Ornamental shrub plantings appear to be healthy. There are some thin areas where plants should be in-filled. Mulch should be added to bed area.

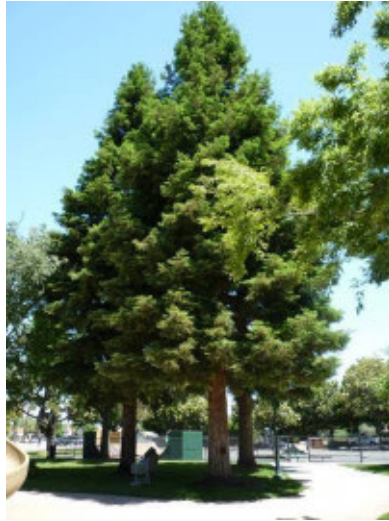
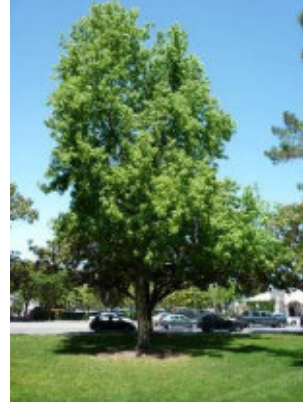
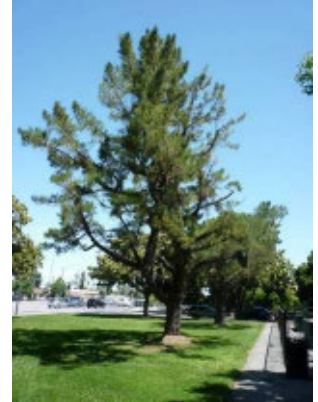
L38

The Redwood grove adjacent to the Skate Park is in great condition. There is a drain inlet in the middle of the group. A large mature Liquidambar in the lawn area appears healthy. The Pine tree adjacent to skate park does not have a nice uniform shape, but does provide good screening.

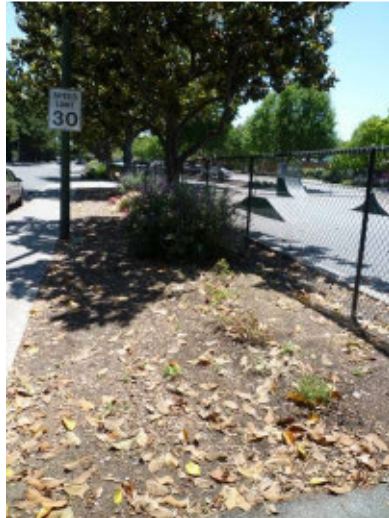
L39

Trees along Crisanto Avenue near the Skate Park appear to be in good health. Shrub planting beds are very thin. If screening the Skate Park is desired, additional shrubs should be planted.

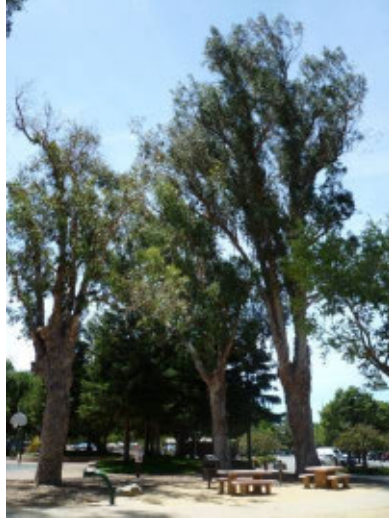
Very large mature Eucalyptus trees throughout the area are not in the greatest condition, but provide significant shade for users. Selective pruning would likely reduce the risk of limb drop. The large expanse of mulch area is adequate for this area in lieu of shrub or ground cover planting.

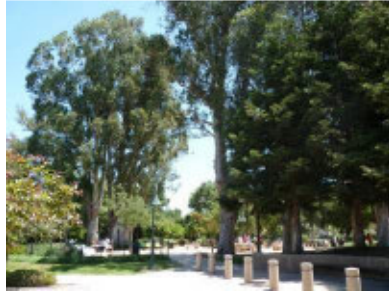
L41

The Redwood grove mixed in with Eucalyptus trees around the perimeter are in great condition. This lone Canary Island palm is tucked among the redwoods and Eucalyptus. It seems to be thriving and should be protected.

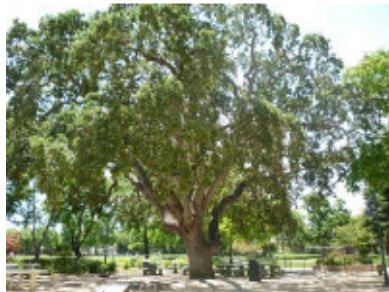
L42

Very large mature Oak tree is at the heart of the Group Picnic Area. The area around the tree should not be disturbed to ensure the survival of the Oak. Smaller oak trees in the picnic area provide some shade and there is a newly planted oak tree.

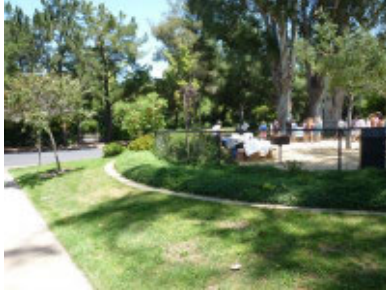
L43

Shrub and ground cover on both sides of fence is generally in good condition. Ornamental trees around the perimeter are nice. There are some thin areas where shrubs have been removed. These areas should be in-filled with appropriate planting.

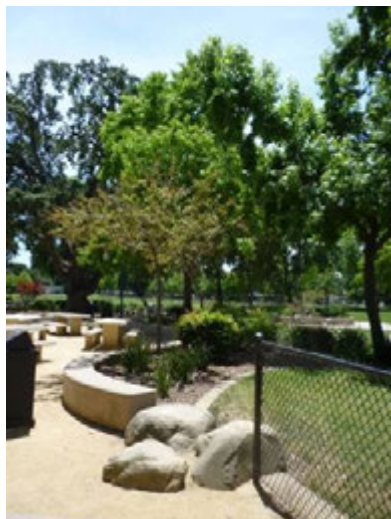
Ornamental planting in raised planter retaining wall is a nice element for pedestrian scale. However, the planting materials have become sparse and should be in-filled. The lawn is worn and should be repaired.

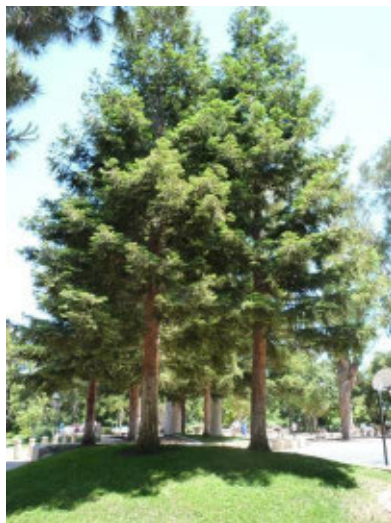
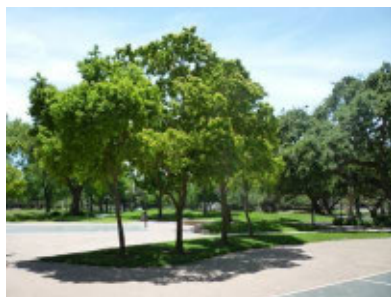
L46

The large mature redwood tree grove in the raised turf mound is healthy and provide great buffer around the courts. Ornamental cherry trees mixed with the redwoods provide good pedestrian scale.

The turf around the rock "outcrop" at the end of the seat walls is showing wear and should be repaired or replaced with mulch.

The smaller shade trees in the lawn between the courts are a nice setting and provide an area for players to rest.

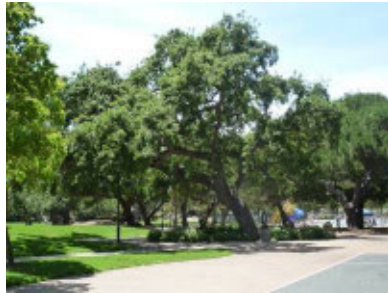
L47

The large mature oak tree being supported by posts is not safe; however, the tree appears to be in good health. Ornamental shrub planting at the base of the tree is full and lush.

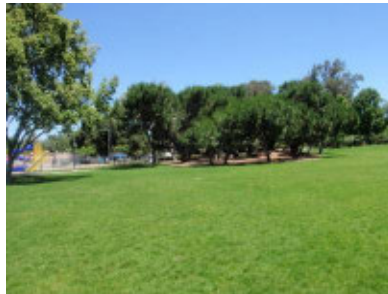
L48

The large grove of mature Stone Pine trees appear to be healthy and thriving. The mulch area around base of trees provides a nice low maintenance solution. A lone queen palm in good health and adjacent to pool seems out of place. The palm could be relocated if it impacts pool maintenance.

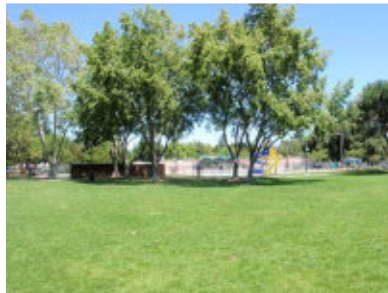
L49

The large mature Sycamore tree grove adjacent to the pool and the Great Lawn is very healthy and thriving.

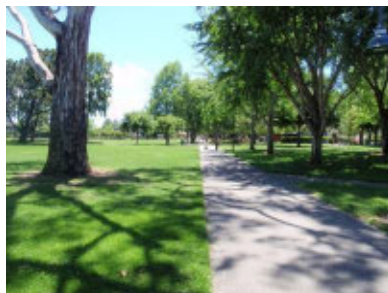
L50

The asphalt path is in good condition. When the park is at its peak use, the size of the path can be too narrow for pedestrians, strollers, and bicycles all to use the path and safely pass one another.

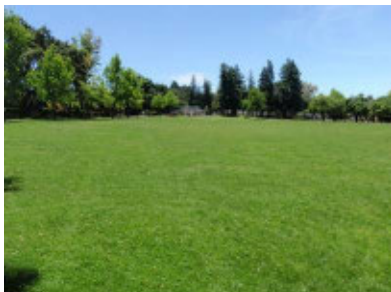
L51

The Great Lawn is a natural turf play and exercise area that is full with lush green grass. A herbicide program should be considered to eliminate weeds throughout the lawn.

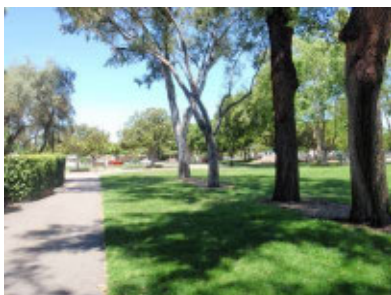
L52

Large mature Eucalyptus trees at the edge of the Great Lawn are nice large shade providers.

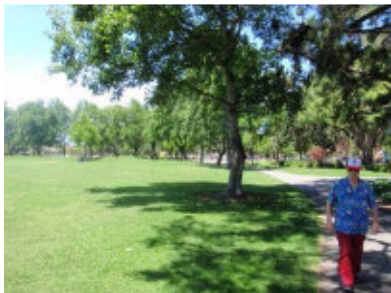
L53

Large mature Sweetgum trees at Great Lawn provide nice amount of shade. Surface roots are present and adding mulch at base of tree to provide cover for the roots should be considered.

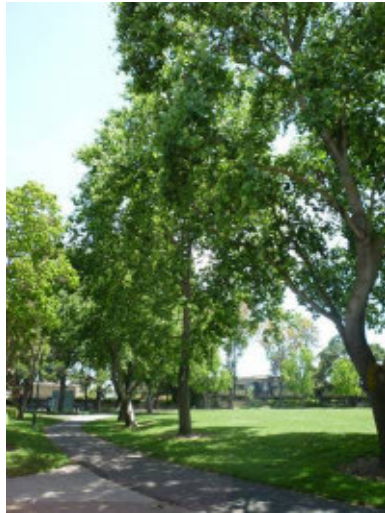
L54

Large mature Tulip trees along the main arching sidewalk at the Great Lawn create a break between the active field area and more passive areas of the park.

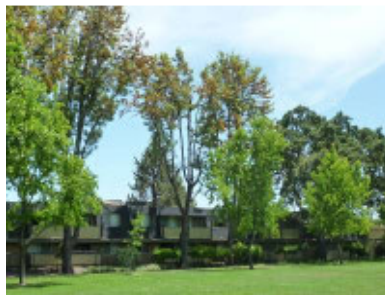
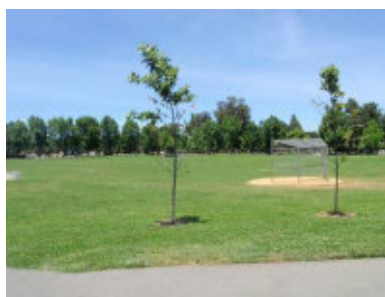
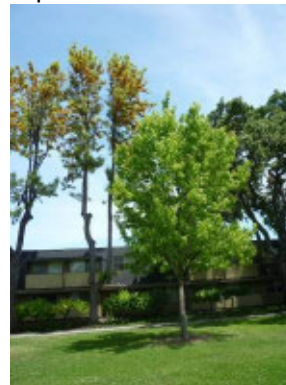
Large mature Green Ash trees along the perimeter provide a stately edge to the park. Although the trees structure has declined over the years, these trees provide a good buffer from neighbors and should be maintained. Young Oak and Tulip trees along the edge of the property appear healthy with the exception of two trees at the most southern corner that should be replaced.

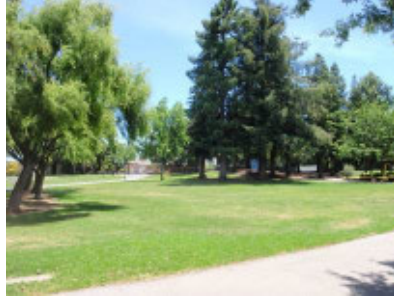
L55

The large mature Redwood tree grove appears to be healthy. It provides a nice perimeter for the pavilion for fire circle area. Mulch under the redwoods is acceptable for its functionality in this area.

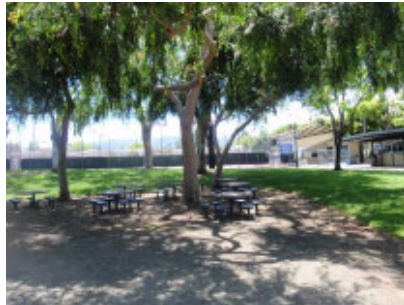
L56

Mature Elm trees and Eucalyptus trees are arranged informally around the tables and seats and appear to be healthy. There has been significant pruning over time and has created trees with odd shapes. These trees provide a good amount of shade for users of this area and should be maintained.

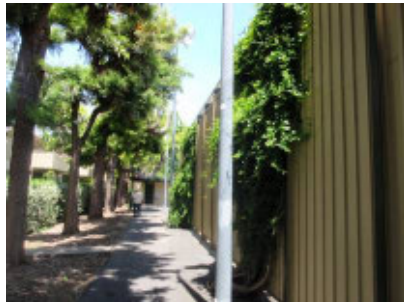
L57

Large Elm trees along property have been pruned significantly over the years, creating severely deformed canopies in these trees. Utility lines also conflict with the large trees in this location. The shrub hedge along the property line is full and dense and should be maintained. The vines planted along the bleachers have outgrown their planting space. If maintaining the vines is desired, enlarged planter areas should be considered.

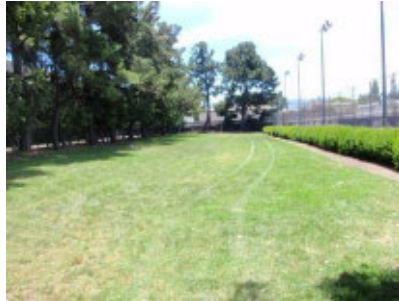
L58

The open lawn area for off leash dog training appears to be full and healthy. Weeds are present throughout the lawn area and a herbicide program should be considered to eliminate weeds. The mixture of large mature trees and the smaller ornamental trees along the perimeter do a good job of providing a screen and buffer between this area and the neighboring property. Shrub hedge along the tennis fence appears to be healthy and full except at the end of the row. This hedge provides a good buffer between the two spaces.

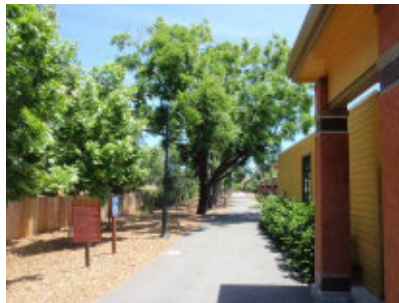
L59

The asphalt path is in good condition with a header board at its edge. Large mature oak trees provide a nice overhead canopy for this pedestrian connection. Newly planted Maple trees along perimeter appear to be healthy. These trees should be regularly maintained to ensure continued health. The large mulch area adjacent to the path is clean and free of weeds. Shrub hedge along play area is healthy and provides nice screen for part of the play area. Large trees in the parking area have lost most of their branches and should be removed and replaced.

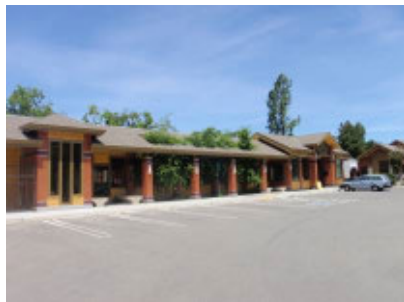
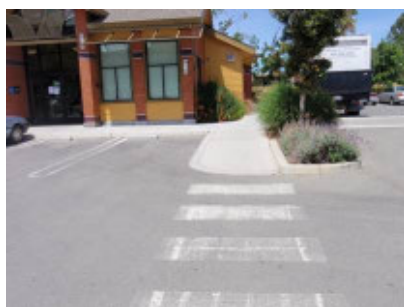
L60

Large mature Bamboo foliage extending through roof cutouts is very lush and healthy. Parking lot end island plantings are lush and full. Trees appear to be generally in good health. Center islands are acting as bio-filtration swales. The planting is generally full and lush with some thin areas.

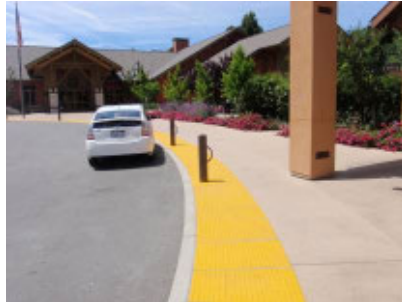
The main entry drop-off is well maintained but appears to need a pressure wash cleaning. The asphalt paving, flush curb, truncated domes, and sidewalk are in good condition. Weeds are present in the decomposed granite areas.

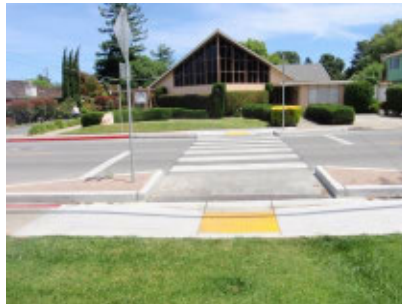
The newly constructed accessible ramp and crosswalk to Rock Church site are in good condition. Parking islands in street provide a safety buffer for pedestrian crossing and parked cars.

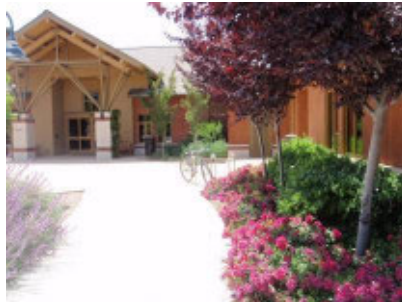
L62

Planting adjacent to the building, and various ornamental flowering and evergreen plants, seem to be full, lush and healthy. Some maintenance is needed to keep the planting clean and dead growth should be removed from the perennial plants.

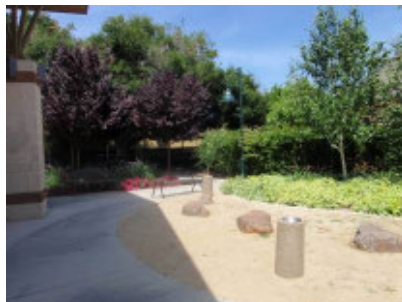
Ornamental plants in raised planters appear healthy. Ornamental planting at patio spaces is healthy and providing a

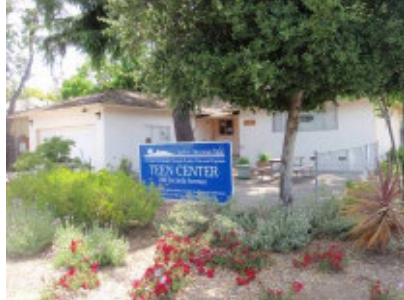
L63

The landscaping around the Teen Center appears to be random, unorganized, scattered and thin. The visual impact of the area could be improved by in-fill planting with an existing plant species. The landscape design concept for this area should tie into the design of the adjacent Senior Center to provide a more cohesive complex. A fresh mulch layer in all the beds would improve the look and portray a clean appearance.

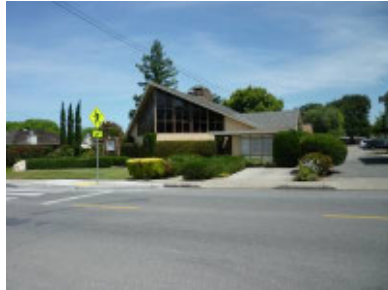
The dense juniper hedge around the front of the building is sheared to 3'-0" high. The appearance of the thick tall juniper is out of scale for the building. Visibility to and from this building is poor due to the dense planting. The front door is not easy to find and the overgrown junipers should be removed to allow for improved site lines to the building. Dense Bottle Brush hedge at building foundation should be removed to improve accessibility to the building.

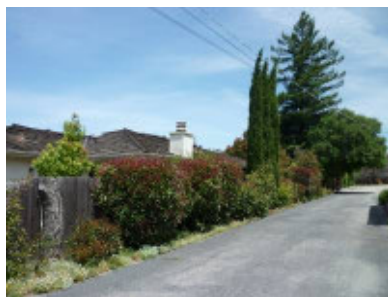
Dense Photinia hedge along perimeter fence provides good screening to adjacent properties. The three Italian cypress appear out of place, but are healthy. Agapanthus along drive is a nice accent. A mulch layer along the south side of the building should be considered to cover exposed soil.

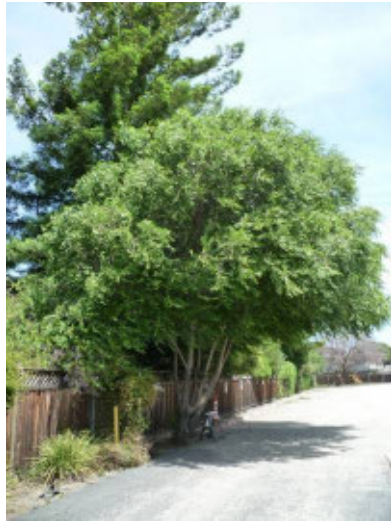
L65

The medium multi-trunk tree along property line fence appears to be healthy. It assists in providing a good screen from the neighboring property. Ivy growing on wooden fence appears to be coming over the fence from the adjacent property.

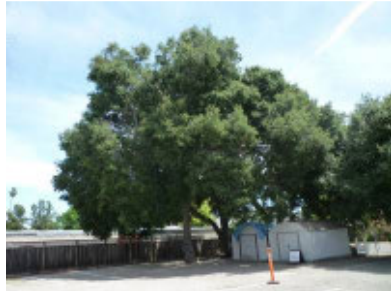
L66

Two large mature oak trees in the southeast corner of the property should be protected and maintained. The dead tree in northeast corner of the property should be removed.
